Norwegian fridge recycling put to the test: Hvitevareretur commissions RAL to audit all plants in Norway

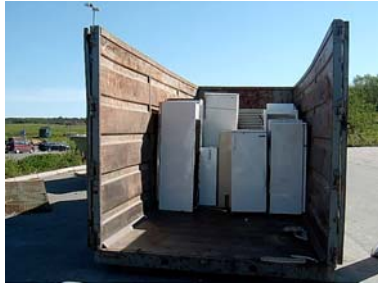
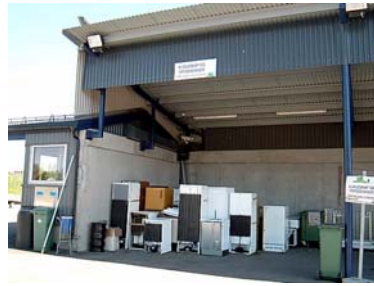
(Left and centre: Examples of good storage practice / Right: Example of poor storage conditions)

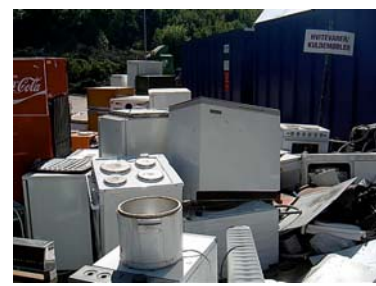
However, despite an ideal underlying infrastructure, the RAL tests showed that there was room for improvement at many of the collection sites. *'When one considers that some appliances, and therefore some of the cooling circuits, are over 25 years old and severely rusted, it is clear that these appliances are highly susceptible to damage. It is therefore all the more important that everyone involved in the processing chain – from the private household to the treatment plant – exercises extreme caution when handling and working with waste refrigeration equipment,'* said Becker. While many of the sites inspected were up to standard, at a number of collection facilities, an inadequate level of care was used when handling waste fridges. Commenting on the results of the RAL audit, the Technical Director of *Hvitevareretur*, Thor Christian Wiik Svendsen said: *'Oil and CFC emissions are avoidable environmental burdens, which result when waste fridges and freezers are knocked or incorrectly stored, for instance when they are laid on their cooling coils. Another fact that we have learned from the RAL audit is that many of the collection sites make a poor visual impression because of the disorderly way in which waste goods are stored.'*

The constructive criticism offered by RAL will be used in the near future by *Hvitevareretur* to improve conditions at the collection sites.
